TEST REPORT

Report No.: E5985.02-901-44

PHOENIX METALWORKS, LLC
D/B/A PHOENIX PANELS
Lynden, Washington

PRODUCT TYPE: Wall Cladding System
SERIES/MODEL: Phoenix Rise

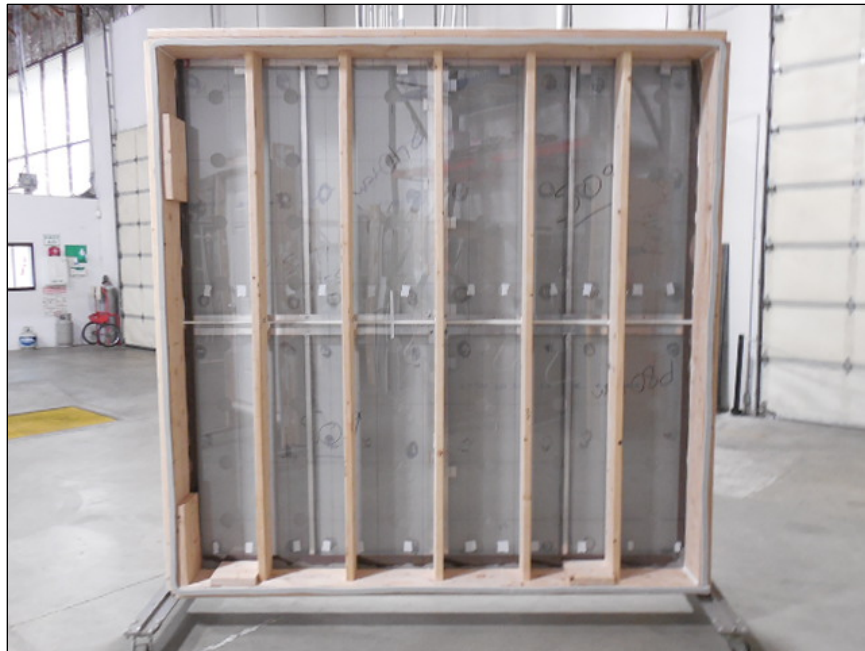
Test Wall Interior

5.3 Test Wall Construction: The 96" wide by 96" high test wall was constructed of 2 x 6 Douglas-fir wood studs. The studs were spaced 16" on center inside a 2 x 8 wood buck. The stud wall was covered with 3/16" thick clear polycarbonate and sealed and secured to the exterior of the wall. The wall panel system was then installed onto the clear polycarbonate in a manner consistent with normal construction procedures for the system. The polycarbonate was penetrated with thirty 64 mm (2-1/2") holes, allowing an even pressure drop across the back of the cladding system. A flexible silicone boot was sealed over the exterior joints of the specimen to facilitate the application of the required pressure differential.

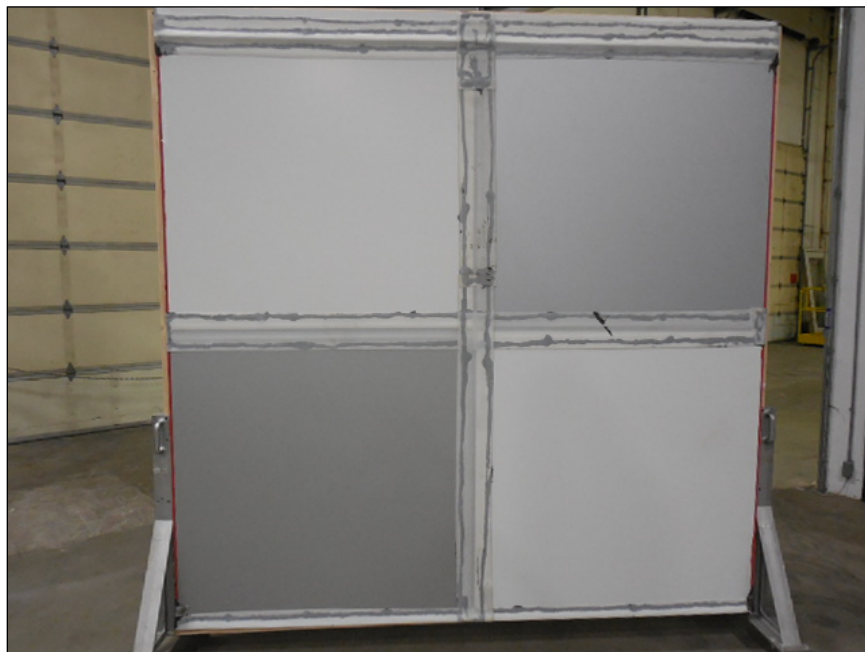
Test Wall Exterior

5.2 Panel Construction: The test specimen was constructed of four 4 mm (0.15") thick Phoenix Panel Systems composite panels. The bottom of each panel utilized 4.8 mm (3/16") diameter weeps, two per panel.

5.4 Reinforcement: One extruded aluminum tube stiffener 25 mm x 25 mm (1" x 1") was adhered to the center of each panel with adhesive sealant.

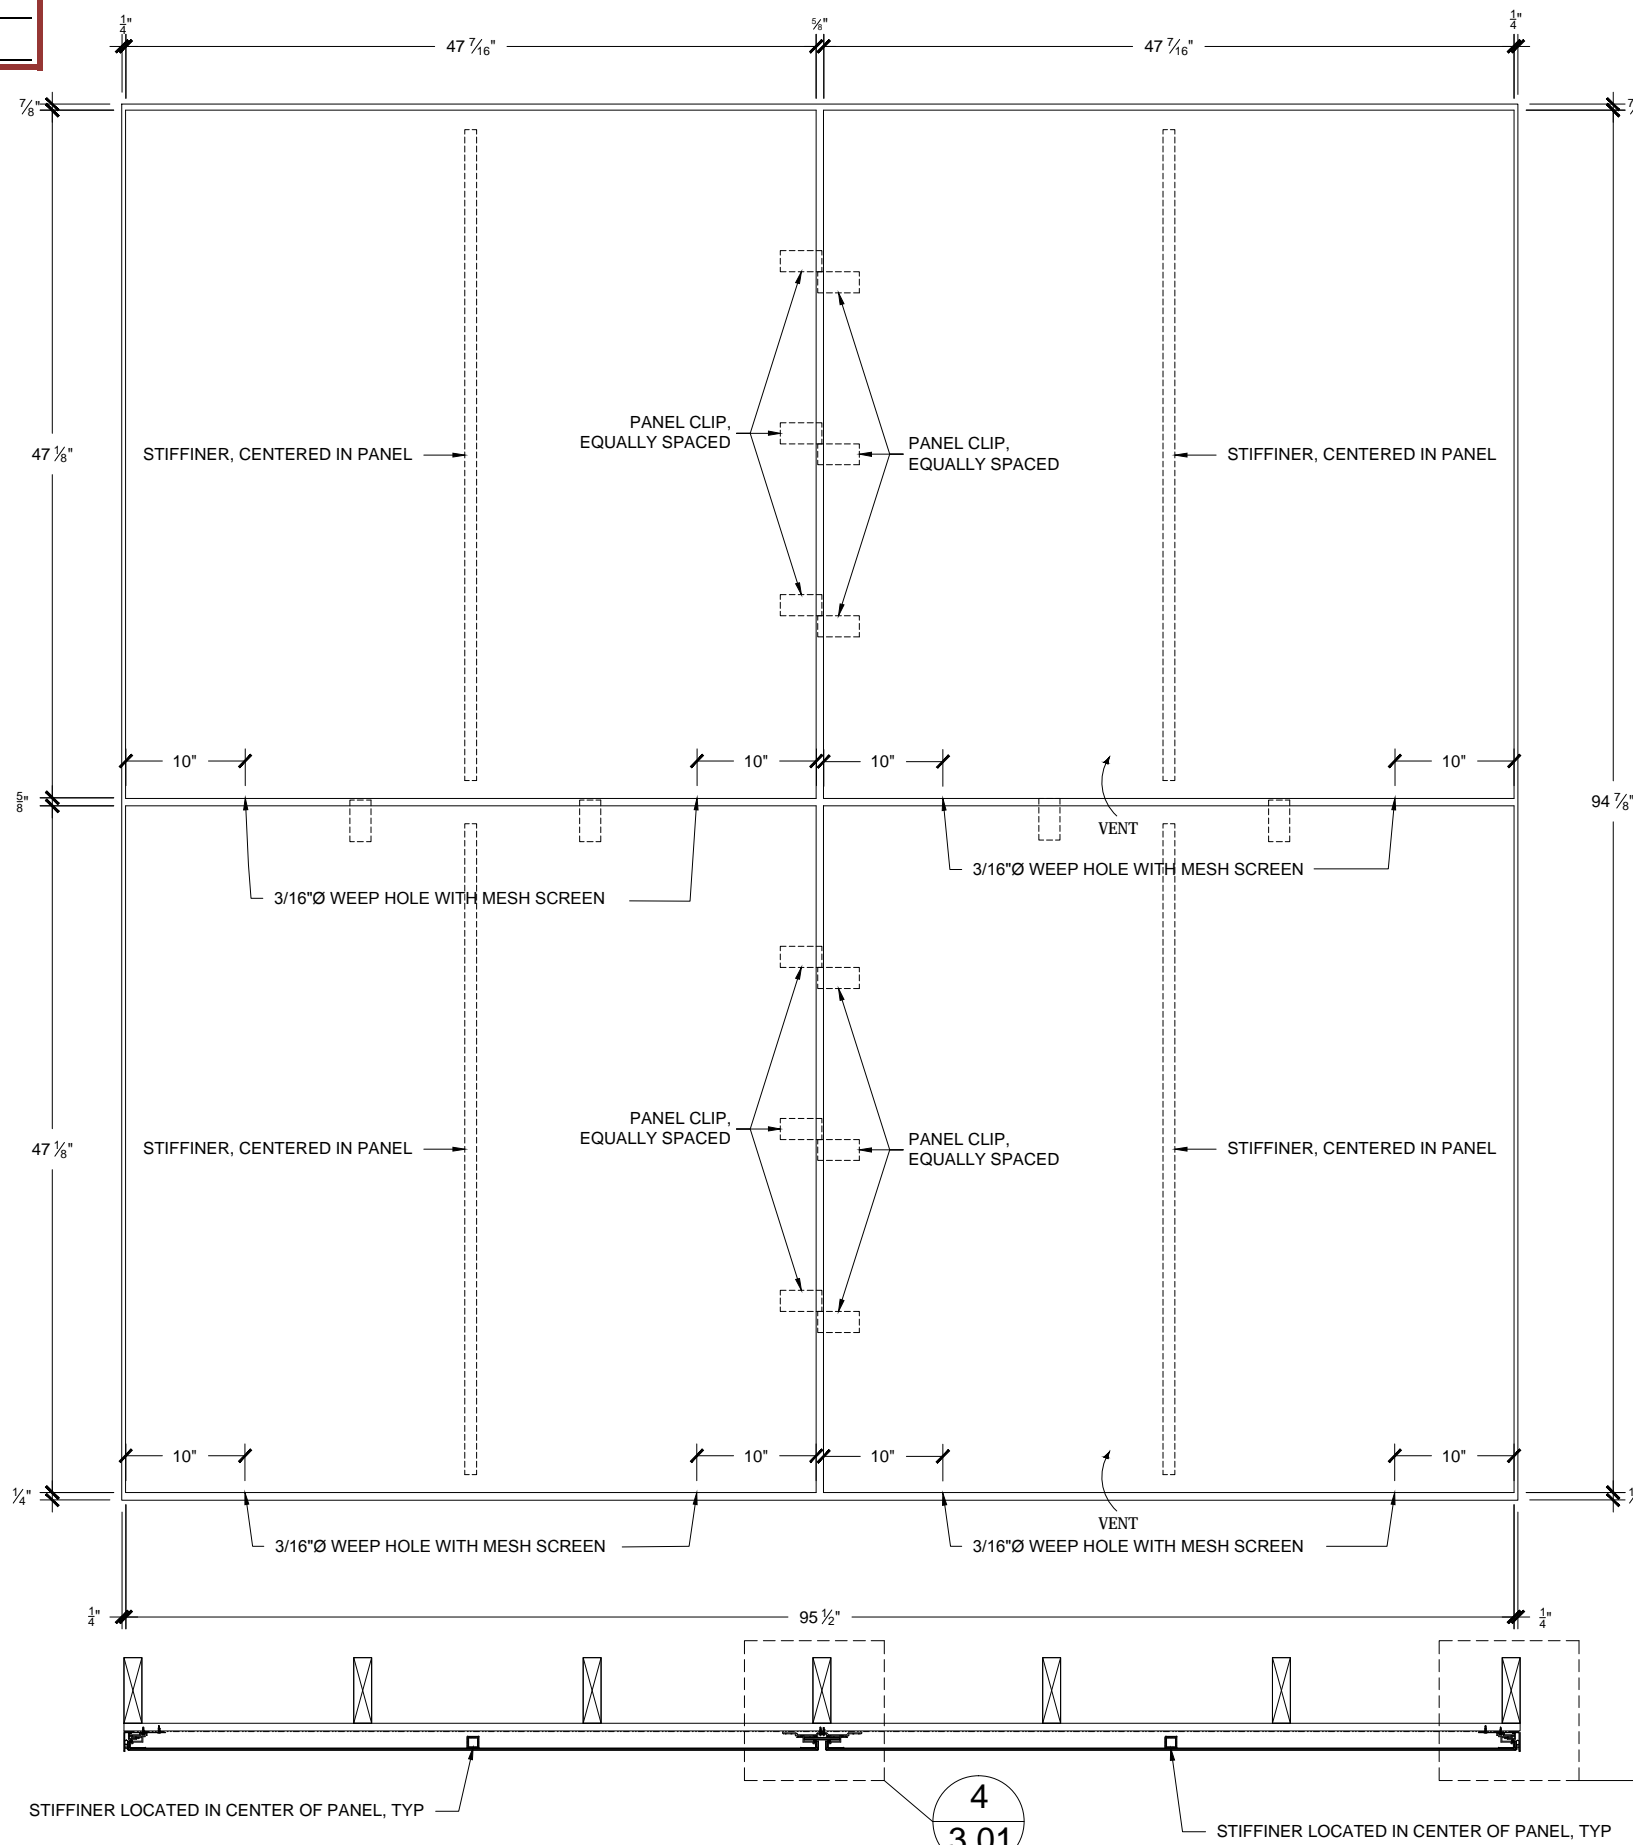
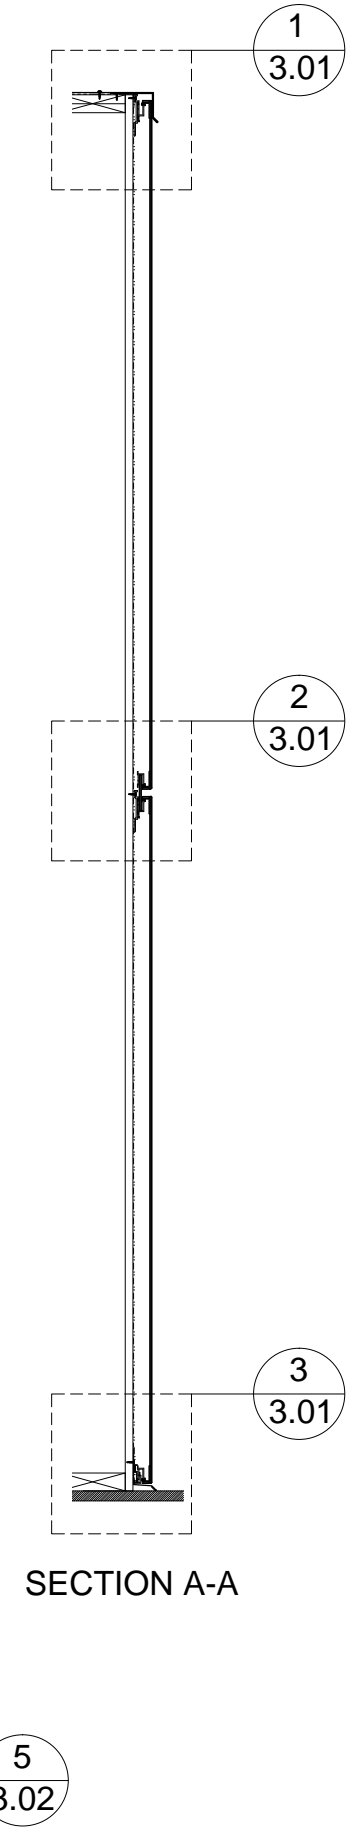
SECTION A-A

SECTION B-B

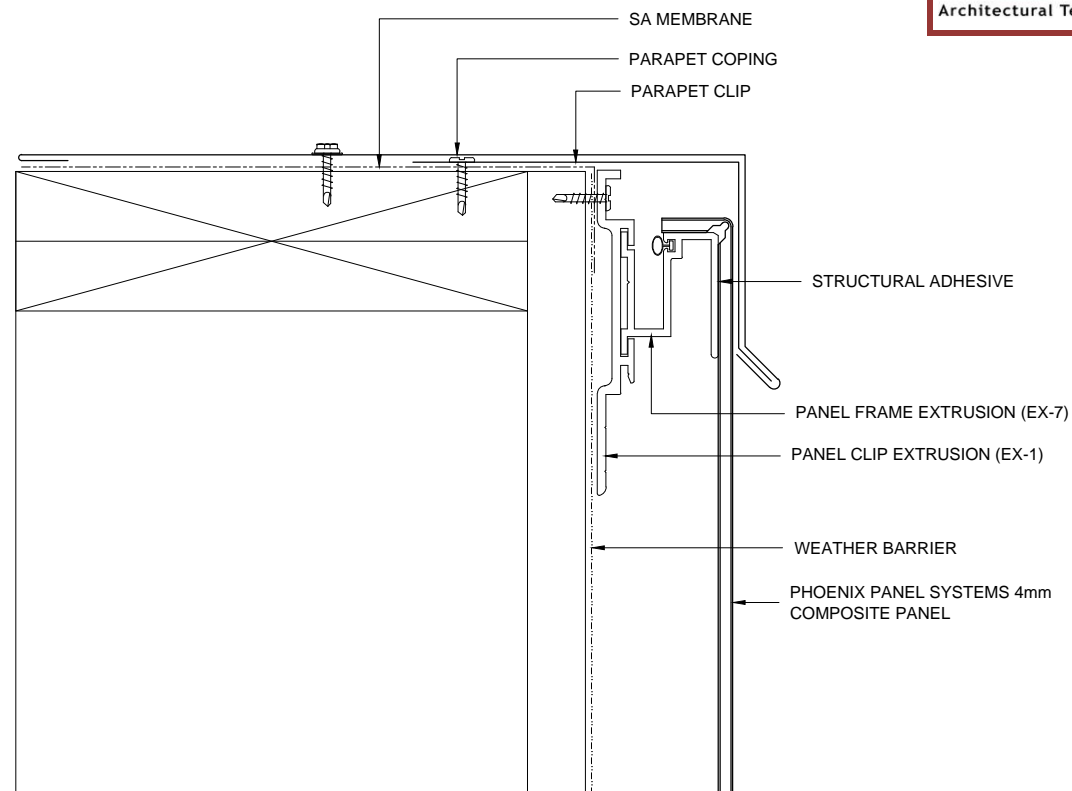
1 PARAPET COPING DETAIL

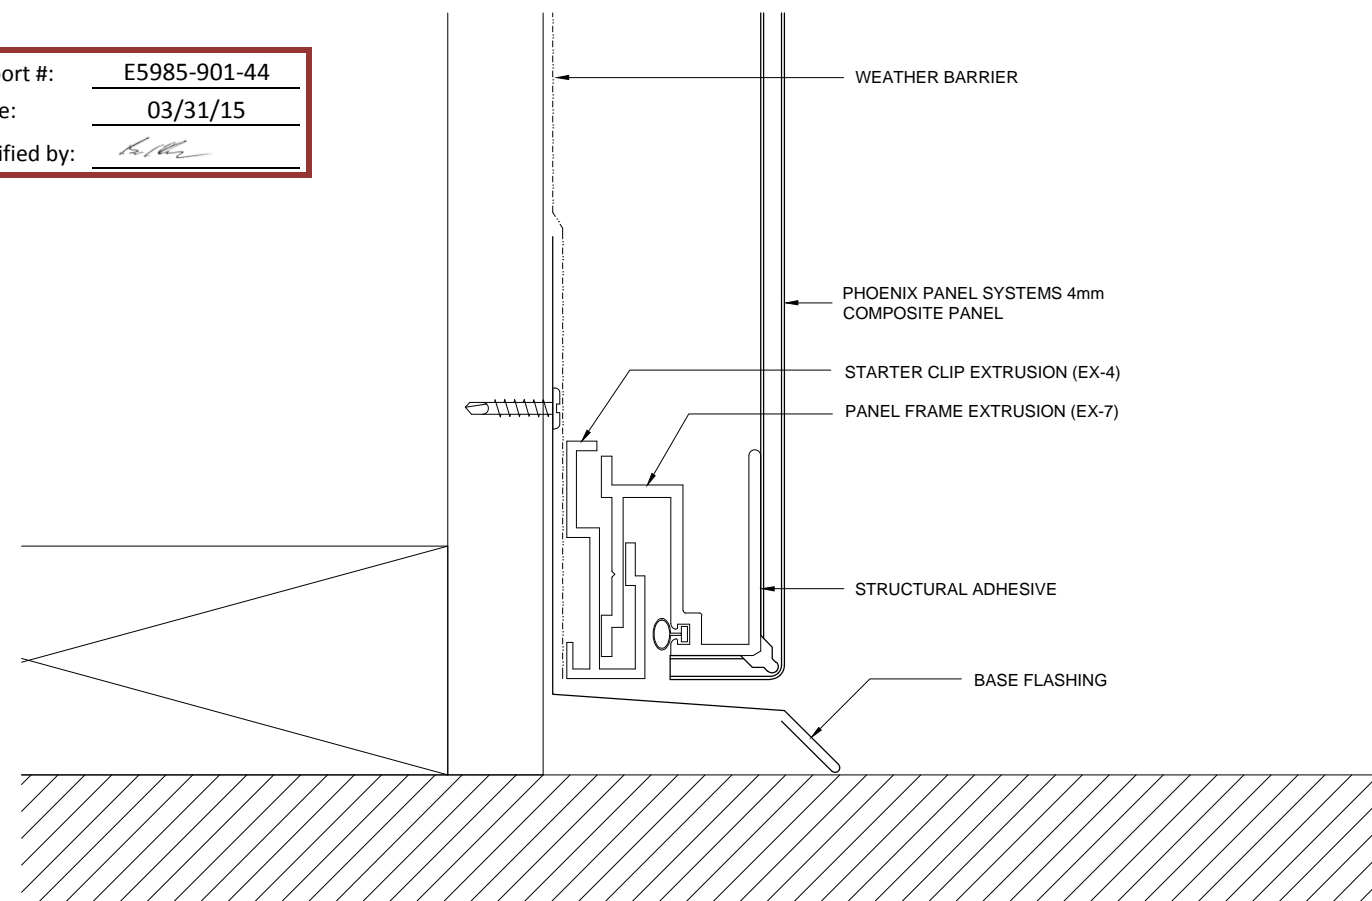
3 BASE DETAIL

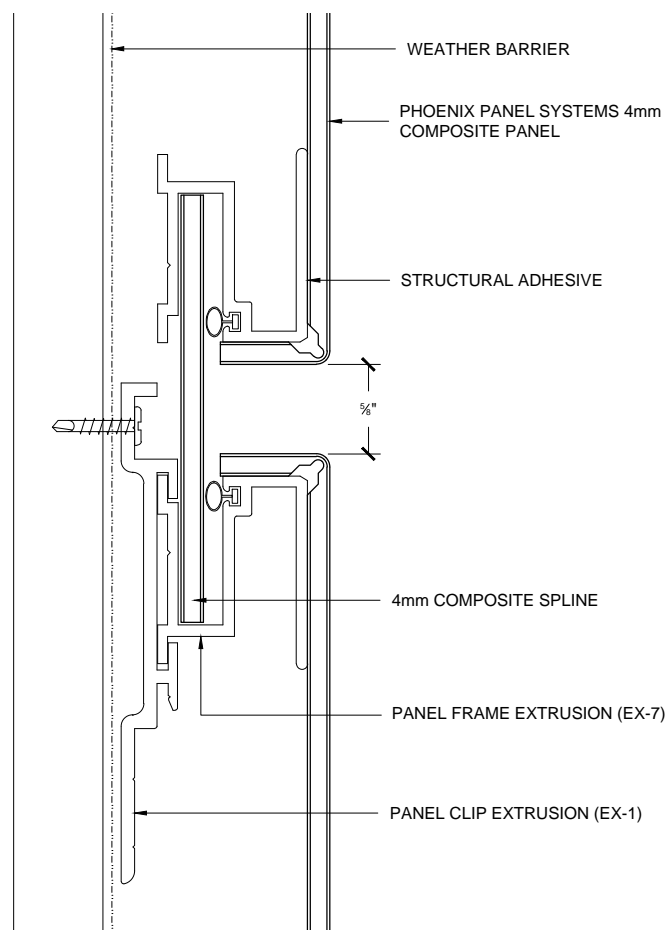
2 HORIZONTAL JOINT DETAIL

The panels were secured to each stud at the interior horizontal edge with extruded aluminum clips. The clips were secured to each stud with one #8 by 1-1/2" screw.

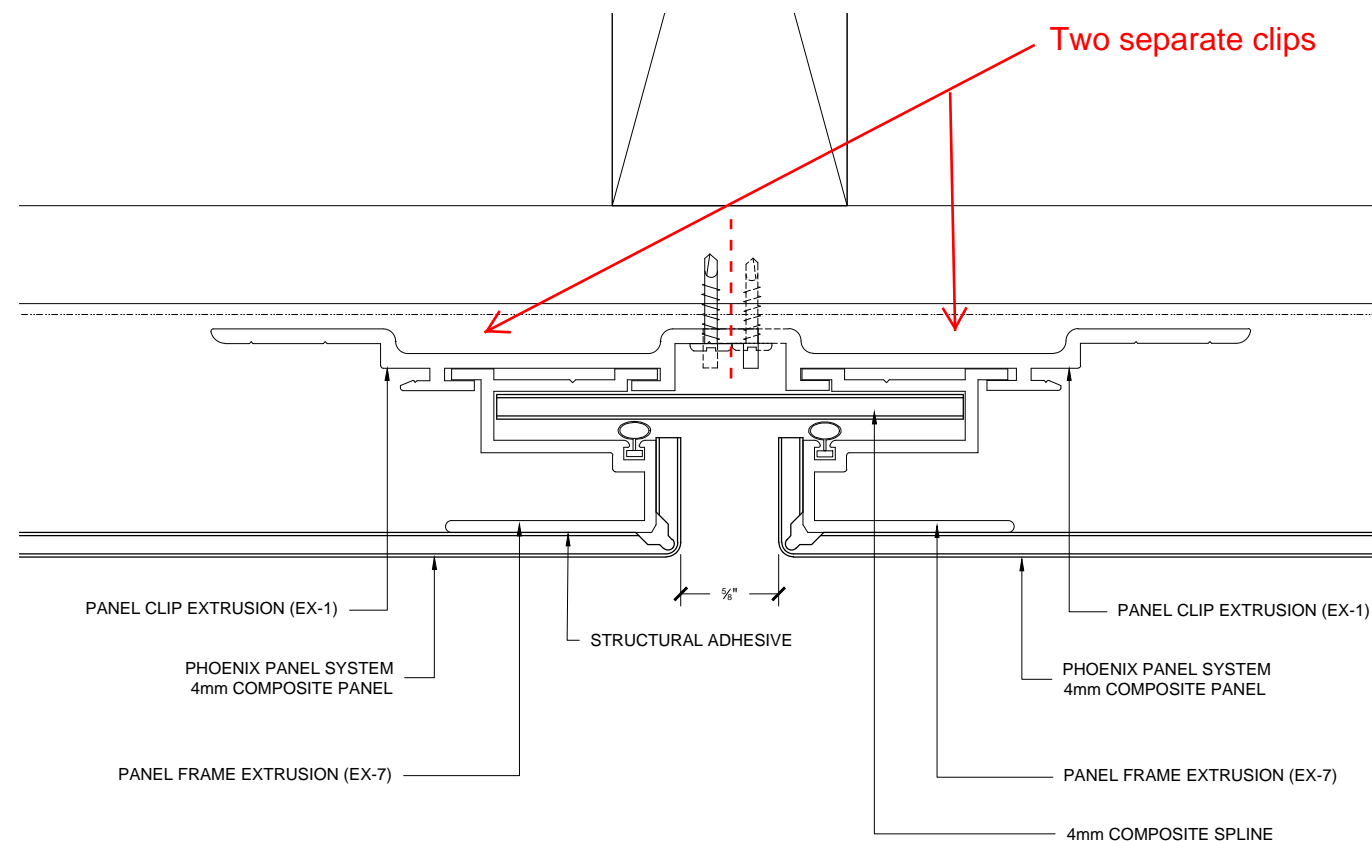
4 VERTICAL JOINT DETAIL

Three extruded aluminum clips were evenly spaced along each panel edge at the vertical joint and secured to the center stud with one #8 by 1-1/2" screw each.

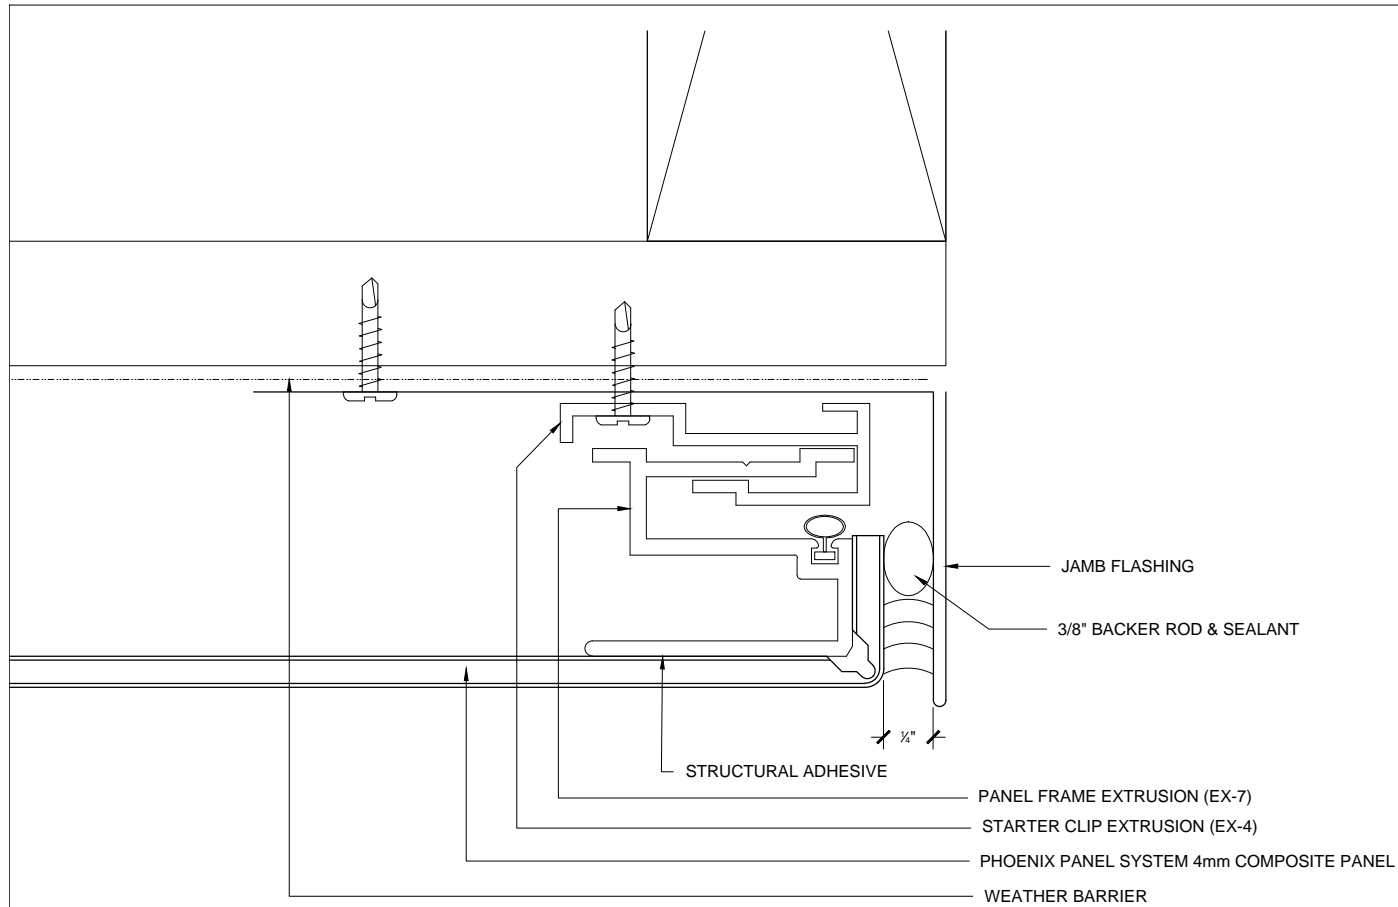
5 JAMB DETAIL
