**PERFORMANCE EVALUATION OF THE CARTER ARCHITECTURAL PANELS INC.,  
“EVO™ RIVETLESS™ PANEL SYSTEM”  
IN ACCORDANCE WITH AAMA 508-07 FOR PRESSURE EQUALIZATION  
BEHAVIOR & WATER PENETRATION RESISTANCE**

Report to:	<b>Carter Architectural Panels Inc.</b> 221 E. Willis Road “A” Unit 18 Chandler, AZ 85286
Attention: cc.:	Mr. Joel McKinley Mr. Bruce Bourne
Telephone: E-mail:	(408) 899 3955 JMcKinley@CarterPanels.com BBourne@ CarterPanels.com
Report No.:	16-06-M0171-2DR 7 Pages, 3 Appendices
Proposal No.:	16-006-438721
Date:	July 7, 2016

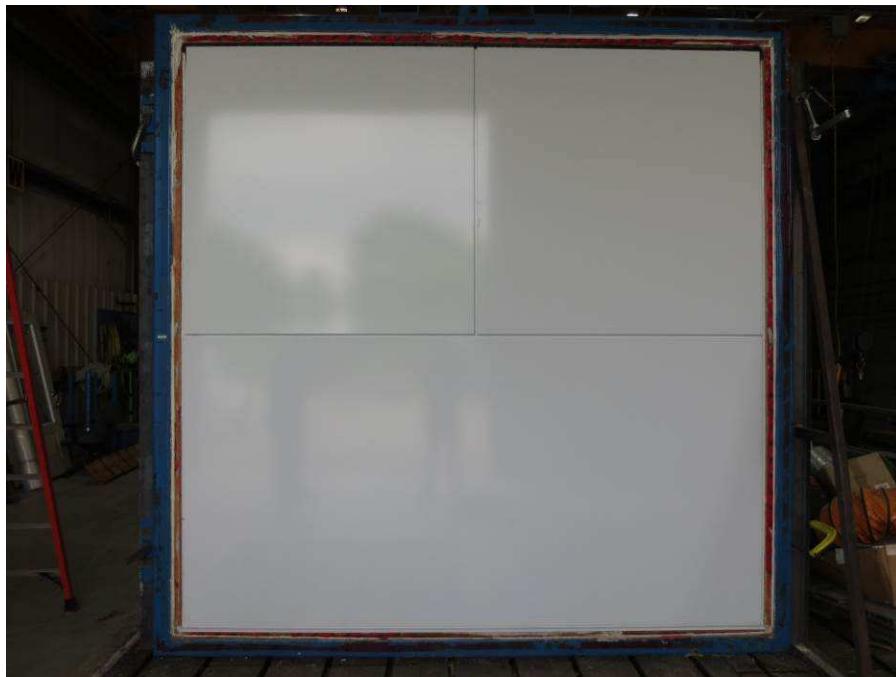
Figure B4 – Completed Wall

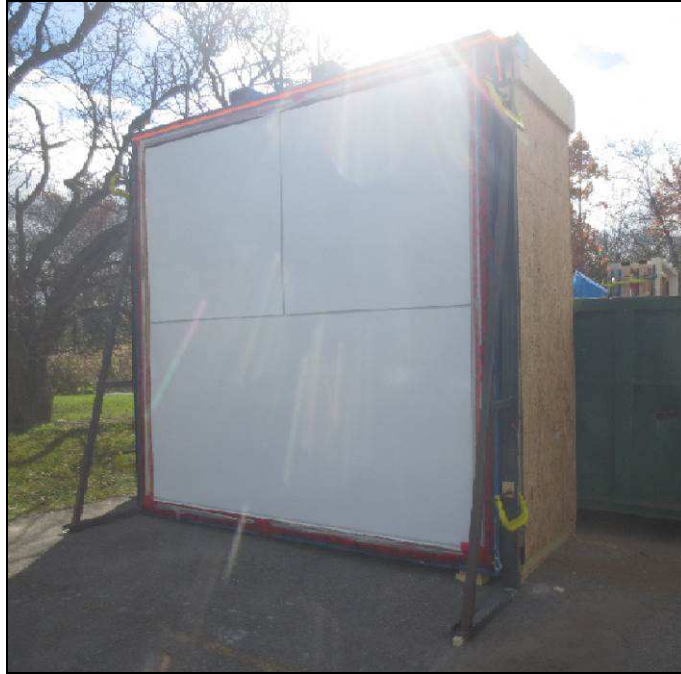
Figure C1 - Specimen Set up in front of viewing chamber

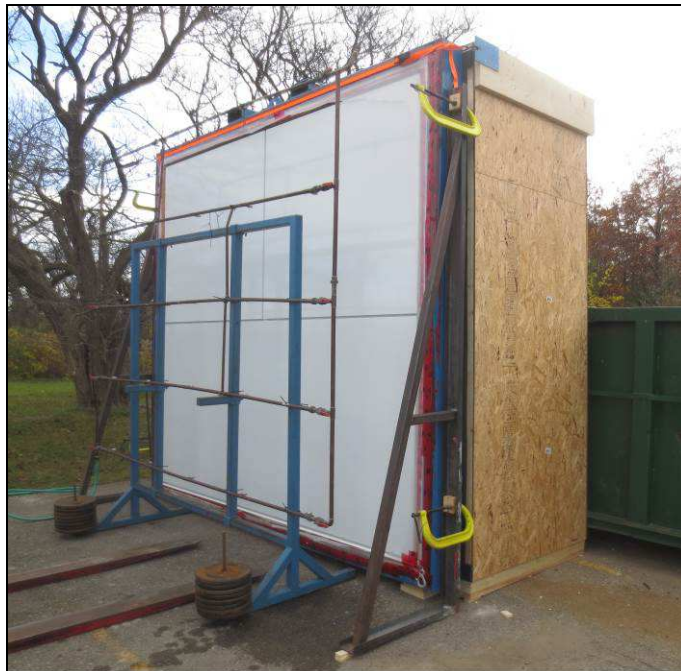
Figure C2 - Spray rack Set up for water penetration

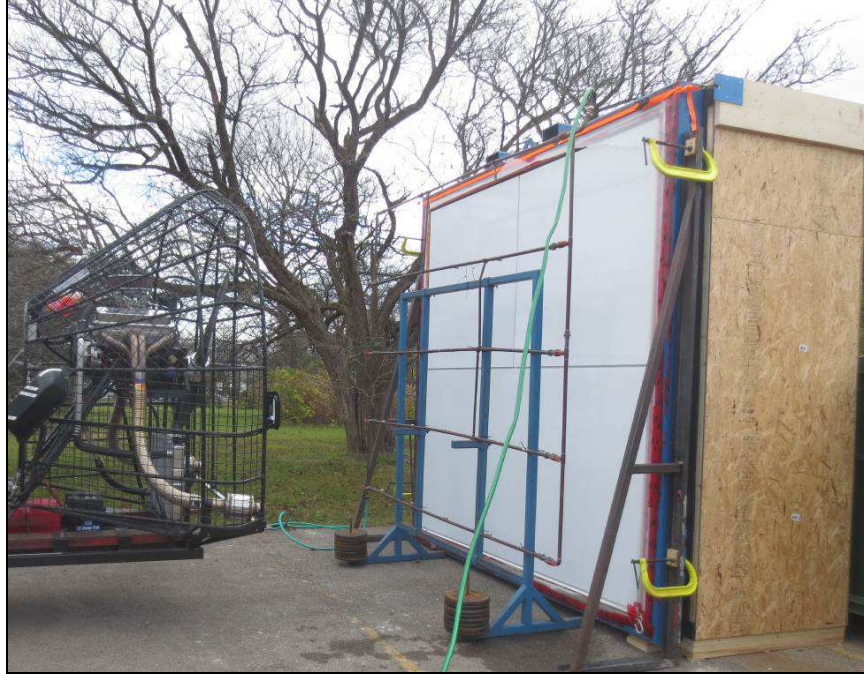
Figure C3 - Wind Machine setup to simulate Dynamic Pressure (AAMA 501.1-05)

Table 4 – Water Penetration Resistance Using Dynamic Pressure AAMA 501.1-05, Section 5.7, Referencing AAMA 501.1-05 Exova Specimen Number: 14-06-M0187 / 14-06-M0363			
Test Pressure (Pa)	Requirements	Test Results	Comment
300 Pa <sup>(2)</sup> (15-Minutes)	<p>All water that penetrates the exterior rain screen cladding shall be controlled and drained to the exterior. All water that contacts the air / water barrier shall be visually observed and recorded:</p> <p>a) Water mist or droplets on the air/water barrier surface; and/or b) Water in continuous stream on the air/water barrier surface.</p> <p>Failure shall be defined as water mist or water droplets appearing in excess of 5% of the air/water barrier surface, or continuous streaming at any location on the air/water barrier.</p>	<p>Water mist and/or droplets were observed.</p> <p>1.39 % of air/water barrier surface area had water misting and / or water droplets.</p> <p>All water that penetrated the exterior rain screen cladding was controlled and drained to the exterior with no continuous streaming observed.</p>	<b>Meets Requirements</b>
