**PERFORMANCE EVALUATION OF THE CARTER ARCHITECTURAL PANELS INC.,
“EVO™ RIVETLESS™ PANEL SYSTEM” WALL ASSEMBLY FOR
AIR INFILTRATION, WATER PENETRATION AND STRUCTURAL PERFORMANCE**

Report to:	Carter Architectural Panels Inc. 221 E. Willis Road “A” Unit 18 Chandler, AZ 85286
Attention: cc.:	Mr. Joel McKinley Mr. Bruce Bourne
Telephone: E-mail:	(408) 899 3955 JMcKinley@CarterPanels.com BBourne@ CarterPanels.com
Report No.:	16-06-M0171-1DR 9 Pages, 2 Appendices
Proposal No.:	16-006-438721
Date:	July 3, 2016

At the request of Carter Architectural Panels Inc., Exova was retained to evaluate an exterior panel system identified as the "EVO™ RIVETLESS™ Panel System" in accordance with ASTM E283, E331 and E330 as defined in Proposal Number 16-006-438721.

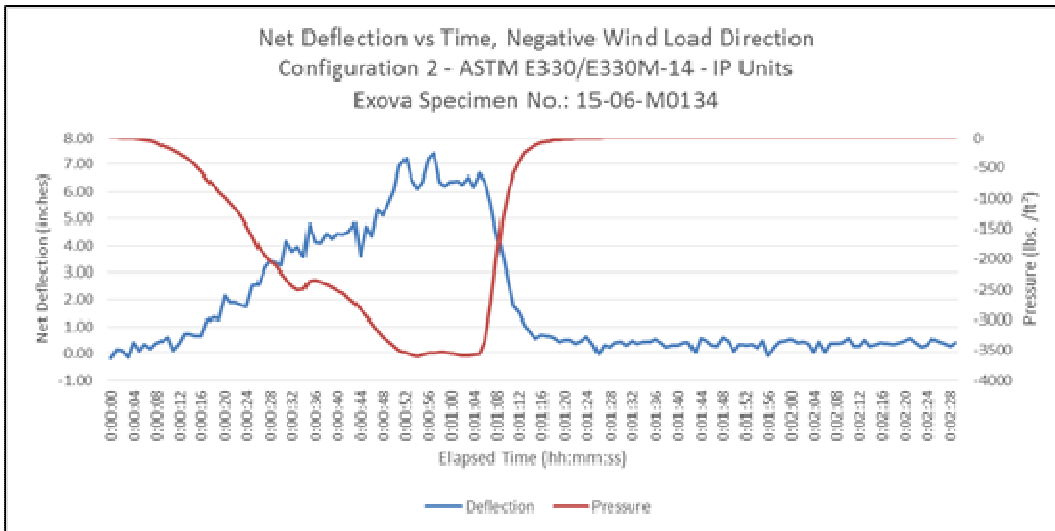
Figure No. 4 – Net Deflection vs Time, Negative Wind Direction, IP Units

Table No. 6 - Summarized Structural Results, Negative Wind Load Direction Configuration 2 – ASTM E330/E330M-14 – SI & IP Units Exova Specimen No.: 15-06-M0134 (Test Date: June 3, 2015)				
Pressure (Pa)	Gauge No. and Deflection			
	1	2	3	Net Deflection
3,591 Pa ⁽¹⁾ (75.0 lbs./ft ²)	-0.1 mm (-0.003 inches)	7.1 mm (0.281 inches)	1.3 mm (0.050 inches)	6.6 mm (0.258 inches)
Residual Deflection	-0.1 mm (-0.006 inches)	0.3 mm (0.014 inches)	0.1 mm (0.004 inches)	0.4 mm (0.015 inches)

Positive Loading Net Deflection Design Load: (+75.0 lbs. /ft²) = 0.204 inches < 0.536 Inch Requirement
Negative Loading Net Deflection Design Load (-75.0 lbs. /ft²) = 0.258 inches < 0.536 Inch Requirement

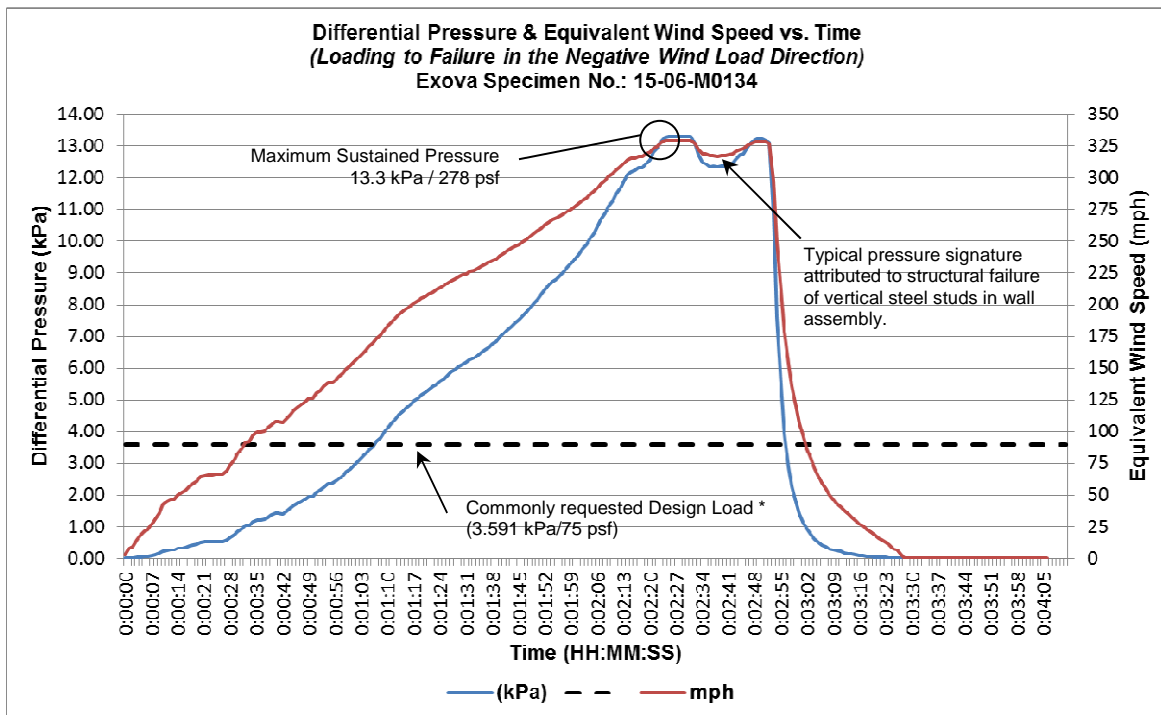
Figure No. 6 – Load to Failure vs. Time, Negative Wind Direction, IP Units

Table No. 7 - Summarized Structural Results Test to Failure in the Negative Wind Load Direction Configuration 2 – ASTM E330 – SI & IP Units Exova Specimen No.: 15-06-M0134 (Test Date: June 3, 2015)	
Maximum Pressure Achieved	Comments
13,325 Pa ⁽²⁾	Cladding System did not disengage from wall assembly. However, vertical supporting steel studs buckled in the center
278 lbs. /ft ²

⁽³⁾ Cladding system did not disengage from the wall assembly. The "EVO™ RIVETLESS™ Panel System" did not fail at 13,325 Pa, whereas, the vertical steel studs behind the wall assembly buckled in the center, thereby, concluding the test procedure.

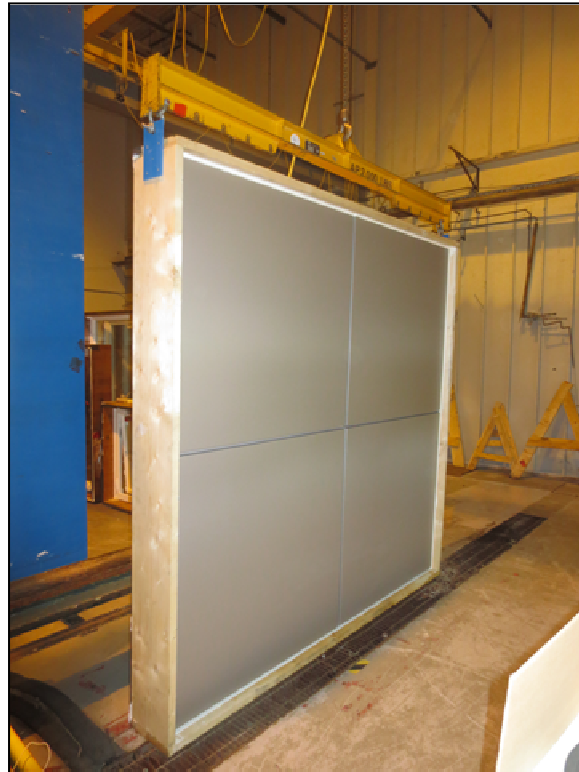
Figure B1 – Test Specimen (Exterior View)

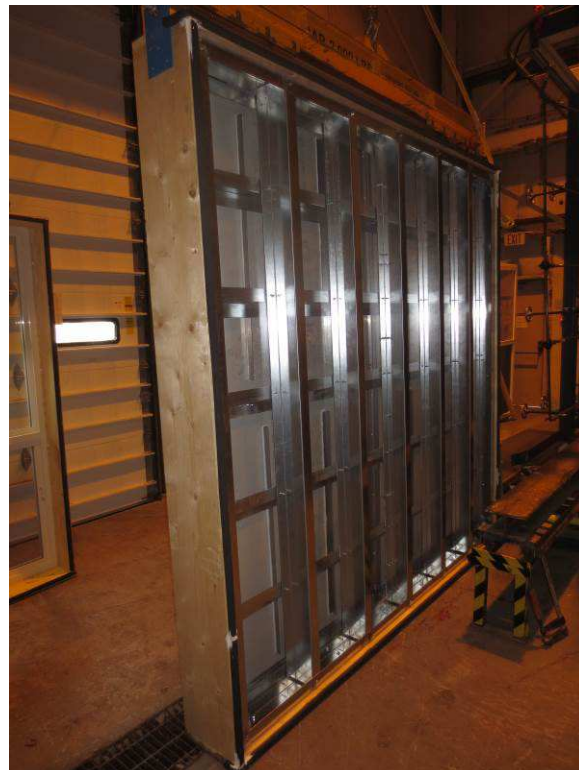
Figure B2 – Test Specimen (Interior View)

Frame Construction: 6" Steel Z-Bar (vertical), 16 ga / 16" O/C
2" Steel Z Bar (horizontal), 16 ga / 16" O/C

Sheathing: 1/4" thick Plexiglas (simulating exterior gypsum sheathing with installed air-tight air barrier / water resistive barrier). Note: Clear Plexiglas (simulated sheathing panels) were required for the observation of water penetration (ASTM E331).
